**Presented By:**  
**ClearWater Solutions**  
 2178 Moores Mill Rd,  
 Auburn, AL 36830  
 Toll Free (877) 230-6228  
 www.clearwatersol.com

## Visual Inspection Report

General Tank Information			
Inspection Date:	September 5, 2018		
Inspected By:	Barrie Dunlap NACE CIP# 64626		
Type Inspection:	Visual		
Tank Name:	River Hills Water Tank		
Tank Location:	4607 Charlotte Hwy		
Tank Capacity:	200,000 Gallon Multi Column Elevated Tank		
Tank Dimensions:	+/- 100' to Bottom		
Number of Columns:	Four		
Type Construction:	Welded Steel		
Riser Manway:	Yes [ X ]	No [ ]	Size: 18" Type: Oval Strong Back
Year Erected:	1972		
External Safety Climb:	Yes [ X ]	No [ ]	Type: Cable
Ladder Gate:	Yes [ X ]	No [ ]	Secured: Locked
Logo:	No		
Exterior Color:	White		
Report & Photos Provided:	Yes		
Type Disinfection:	N/A

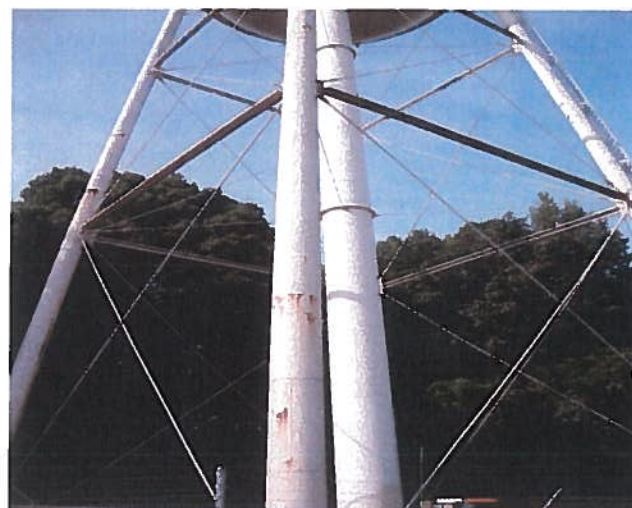
The exterior coating is exhibiting delamination, corrosion, rusting, cracking, chalking and blemishing in various areas on the tank. The influent riser, support columns, bowl and roof seemed to have been improperly coated in the last several years. A Dry Film Thickness test was performed on the tank roof and received an average reading of 10.8 mils. Recommend replacing lower section of column ladder and a full exterior overcoat/spot repair within the next two years.

Corrosion On Support Column

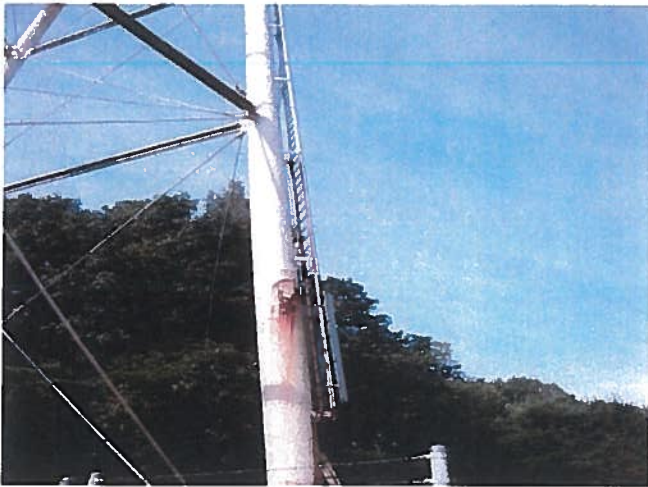
Corrosion & Rust Staining On Support Column

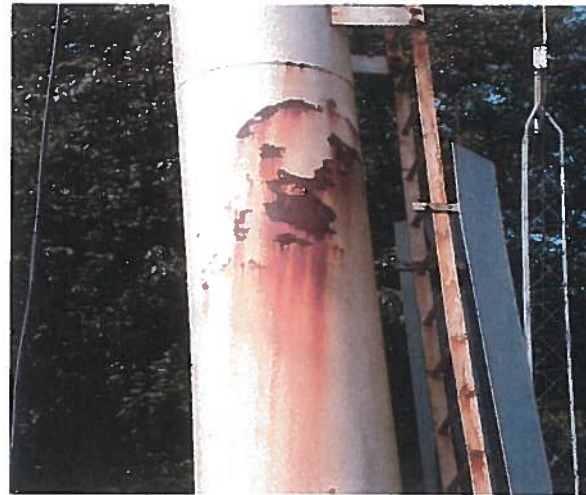
Close Up Of Corrosion on Support Column

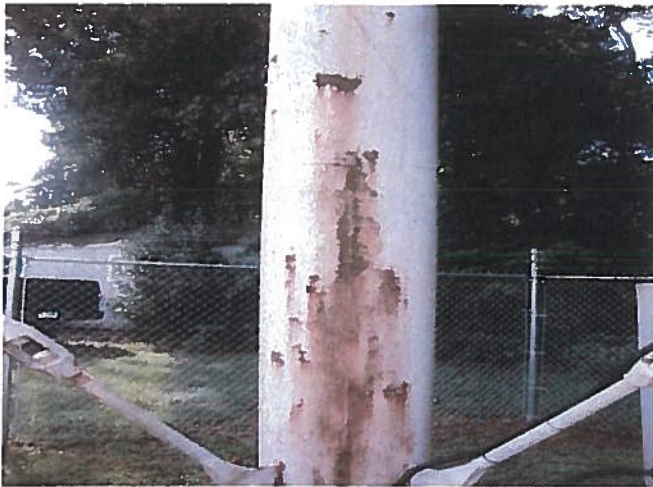
Corrosion & Rusting On Support Column

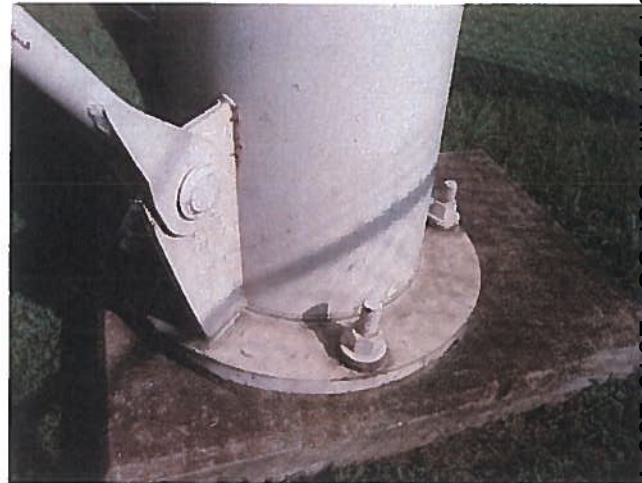
<i>Foundation Conditions</i>	
Are Foundations above Grade:	Yes
Condition of Concrete:	Good
Condition of Grout:	Good
Condition on Anchor Bolts:	Good w/ Minor Corrosion

Anchor Bolts & Concrete Foundation

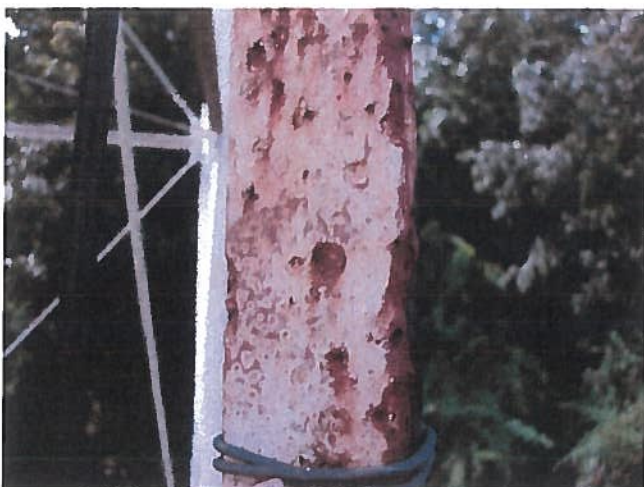
<i>Exterior Conditions</i>	
Condition of Exterior Ladders:	Heavy Corrosion On Lower Section
Does Overflow Extend to the Ground:	No Location: Internal
Does Overflow have a Screen and Flapper:	Yes [ ] No [ X ]
Is Vent Screen Secure:	Yes [ X ] No [ ] : Secondary Fine Screen Unsecured
Is Level Indicator Functioning:	Yes [ ] No [ X ]
Is Tank Site Fenced:	Yes [ X ] No [ ]
Evidence of Vandalism:	Yes [ ] No [ X ]
Evidence of Leaks:	Yes [ ] No [ X ] Location: N/A
Condition of Exterior Coating:	Corrosion at Various Locations
Columns:	Corrosion at Various Locations
Riser:	Good w/ no Corrosion
Bowl:	Good w/ no Corrosion
Shell Wall:	Coating Delamination at Various Locations
Roof:	Minor Spot Corrosion
Rods:	Minor Spot Corrosion
Balcony:	Minor Spot Corrosion
Does the Tank have Antennas:	Yes [ X ] No [ ] Type: Balcony & Roof Mounted
Does the Coating Contain Lead Paint:	Yes [ ] No [ ] N/A

Heavy Corrosion Along Exterior Ladder

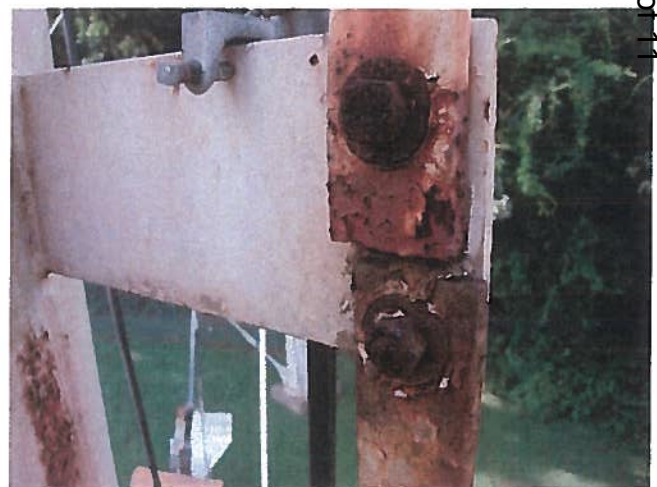
Corrosion On Ladder Bolts

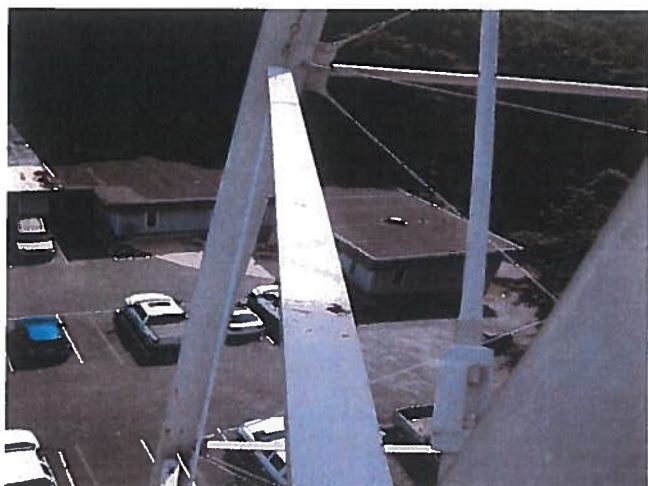
Rusting Present On Tank Strut

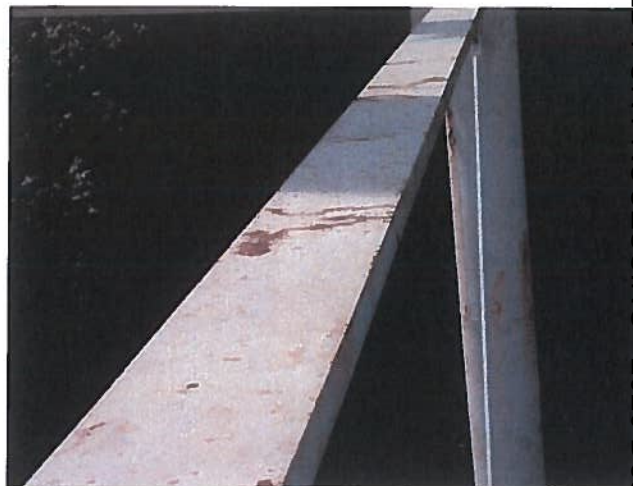
Close Up Of Rusting On Tank Strutt

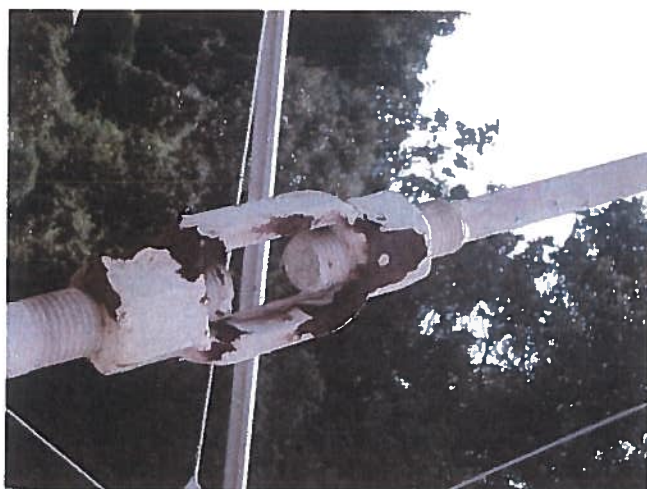
Delamination & Corrosion On Wind Rod

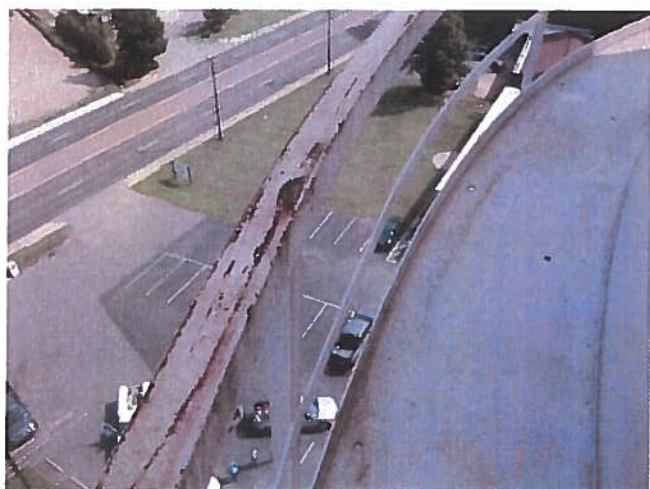
Rusting On Balcony Railing

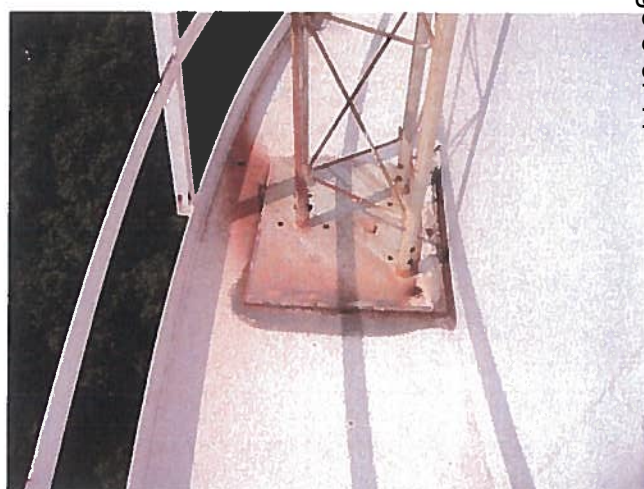
Rust Staining At Antenna Base

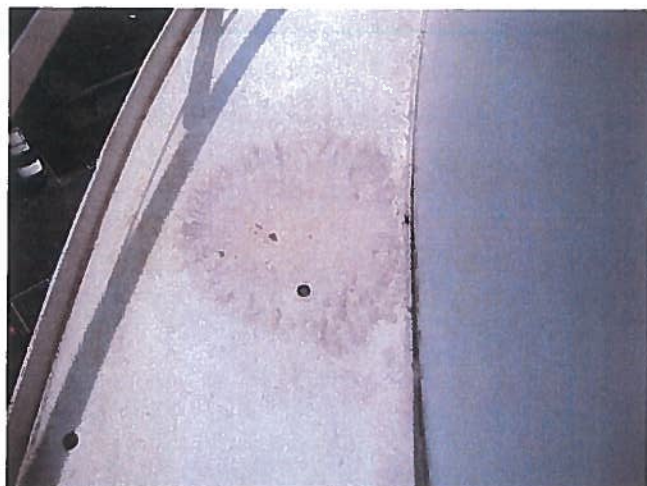
Puddling Water Staining

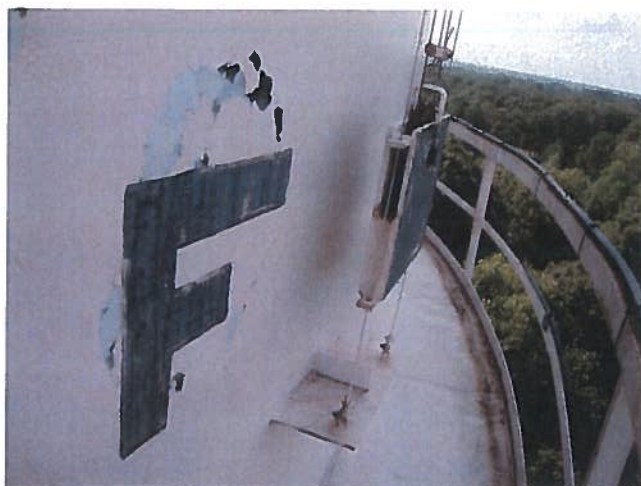
Delamination On Shell Wall & Level Indicator View

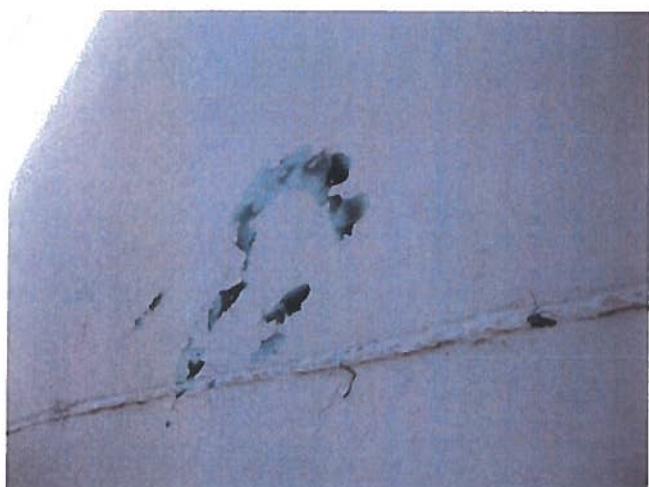
Cracking & Delamination On Shell Wall

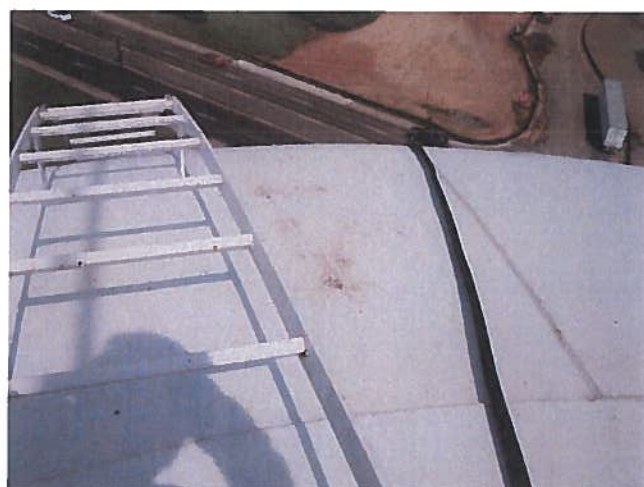
Rusting On Tank Roof

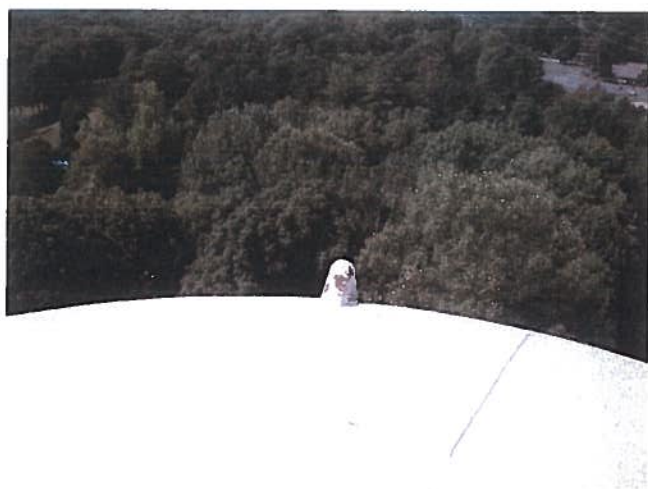
Rusting On Tank Roof

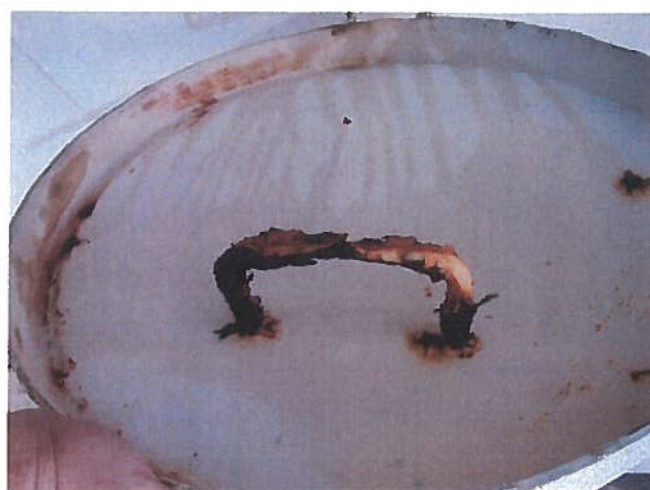
Corrosion On Roof Hatch

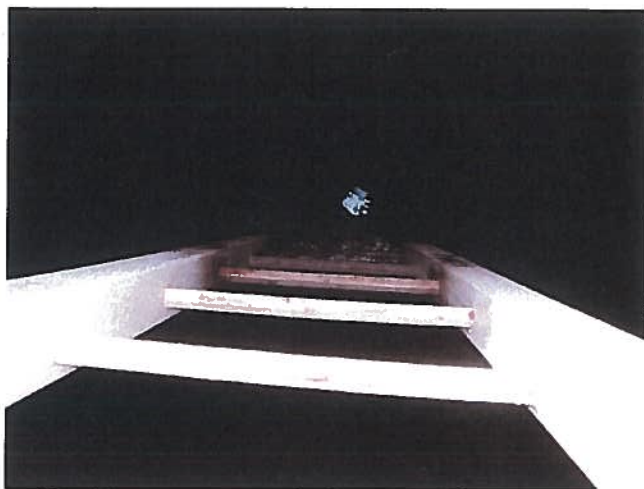
Interior Ladder View w/ Rust Staining

The interior of the tank is exhibiting areas of corrosion, surface rust and rust staining along the roof support beams, shell wall and ladder. Also, sediment is present in tank bowl. Recommend washout/disinfect within one year and a full interior overcoat/spot repair within two years.

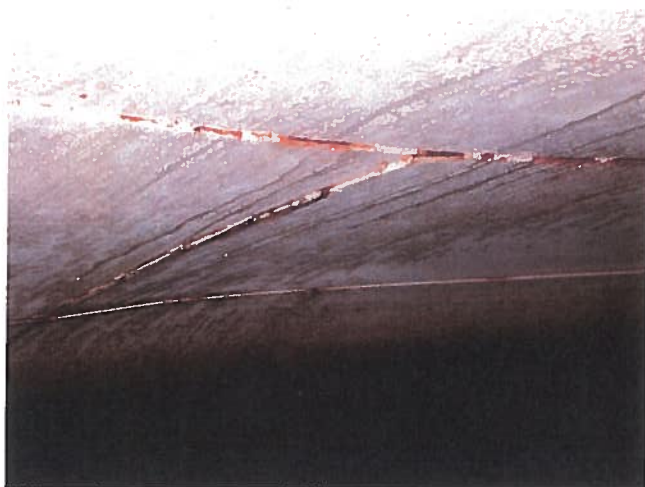
Rusting Along Roof Welds

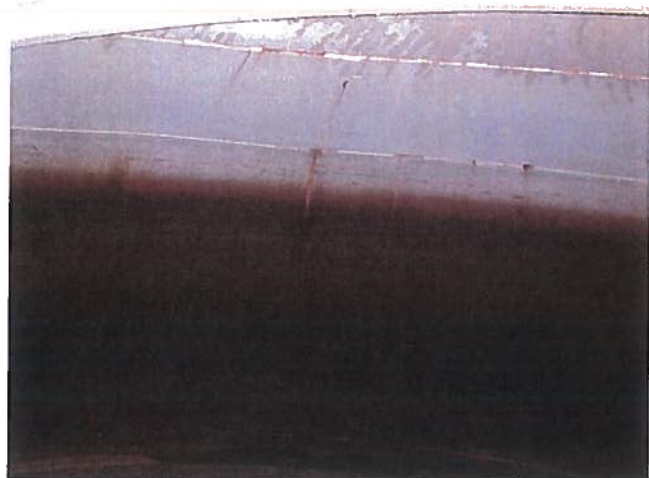
Heavy Rusting & Staining on Upper Shell Wall

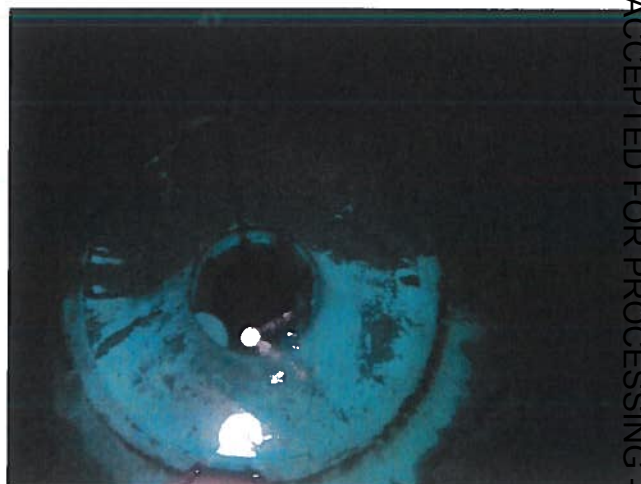
Sediment Present In Tank Bowl

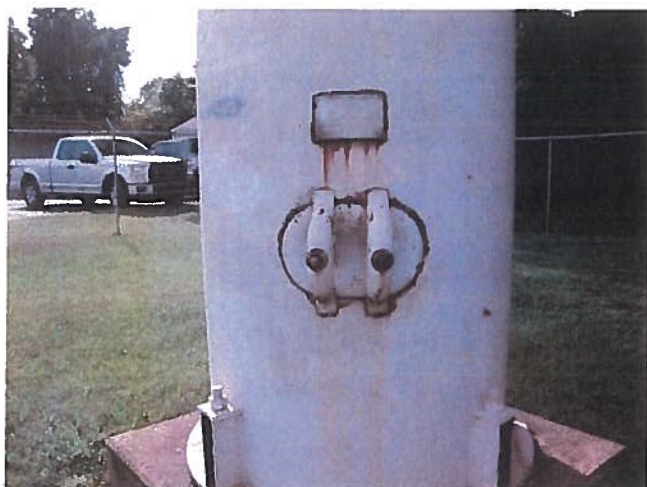
Riser Manway w/ Corrosion on Bolts

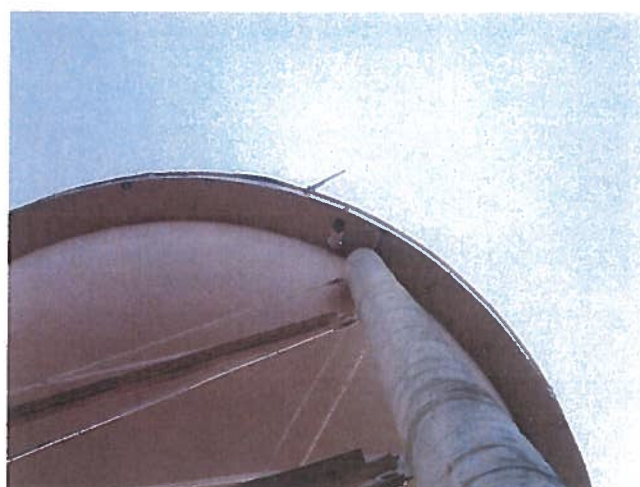
Overflow Pipe View

- Riser manway is secured
- Roof hatch is secured
- Roof vent screen is secured. (Secondary fine screen is unsecured)
- Balcony and roof antennas are secured.
- Ladder gate and safety cable are secured
- Overflow pipe does not extend to ground level

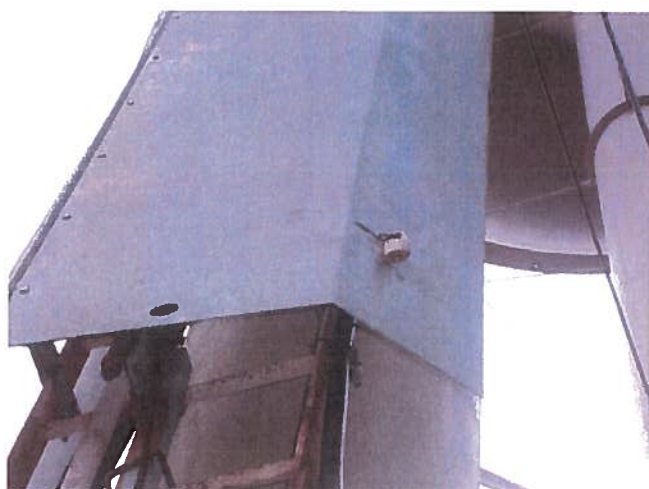
Ladder Gate Secured After Inspection
